**Walmart Inc. (f/k/a Wal-Mart Stores, Inc.) v. Tesla Energy
Operations, Inc. (f/k/a SolarCity Corporation)**
Document 1

**SUPREME COURT OF THE STATE OF NEW YORK
COUNTY OF NEW YORK: COMMERCIAL DIVISION**

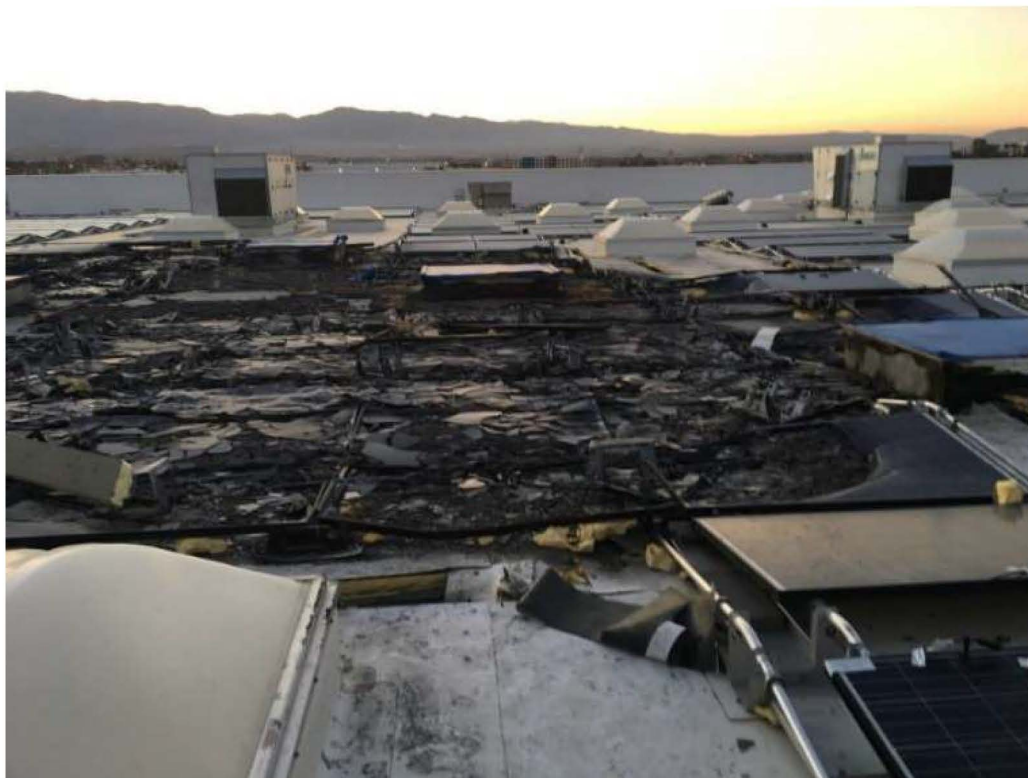
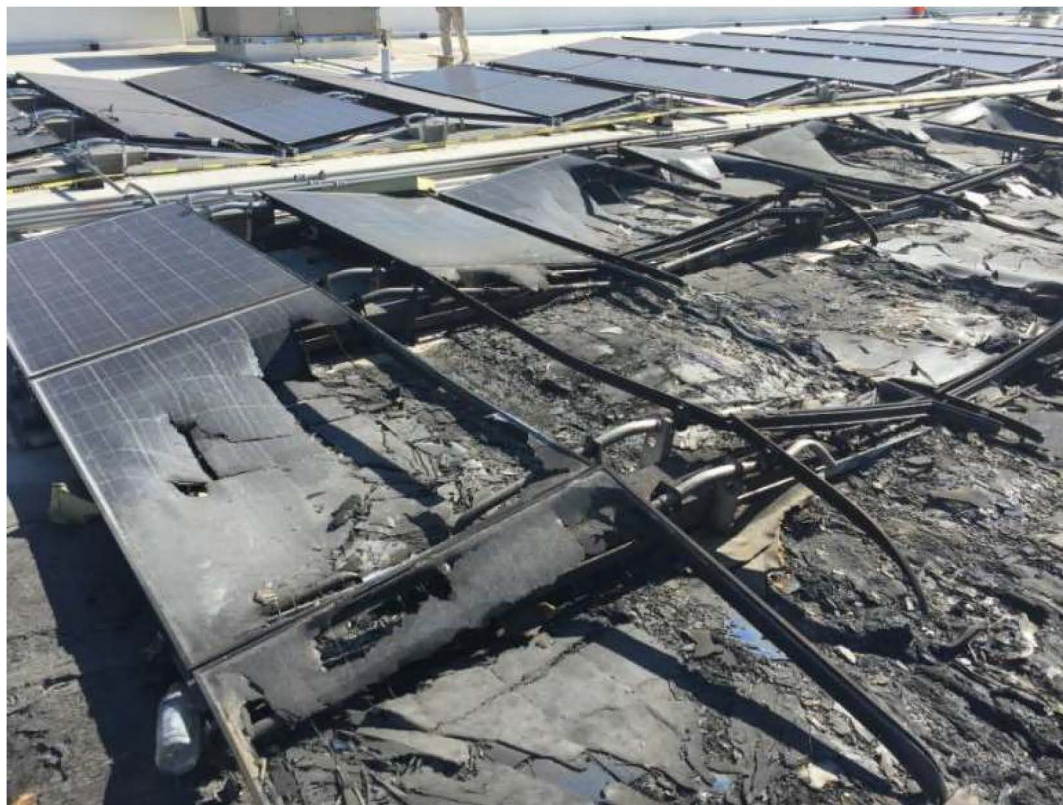
Images of Indio Fire Damage

70. Investigation of the Indio fire revealed a number of installation and maintenance issues indicative of pervasive, systemic negligence and conduct that fell far below the standard of Prudent Industry Practices. As described in greater detail below, among the issues identified were module hotspots, improper grounding and wiring methods, improper connector torqueing, and erroneous as-built drawings.

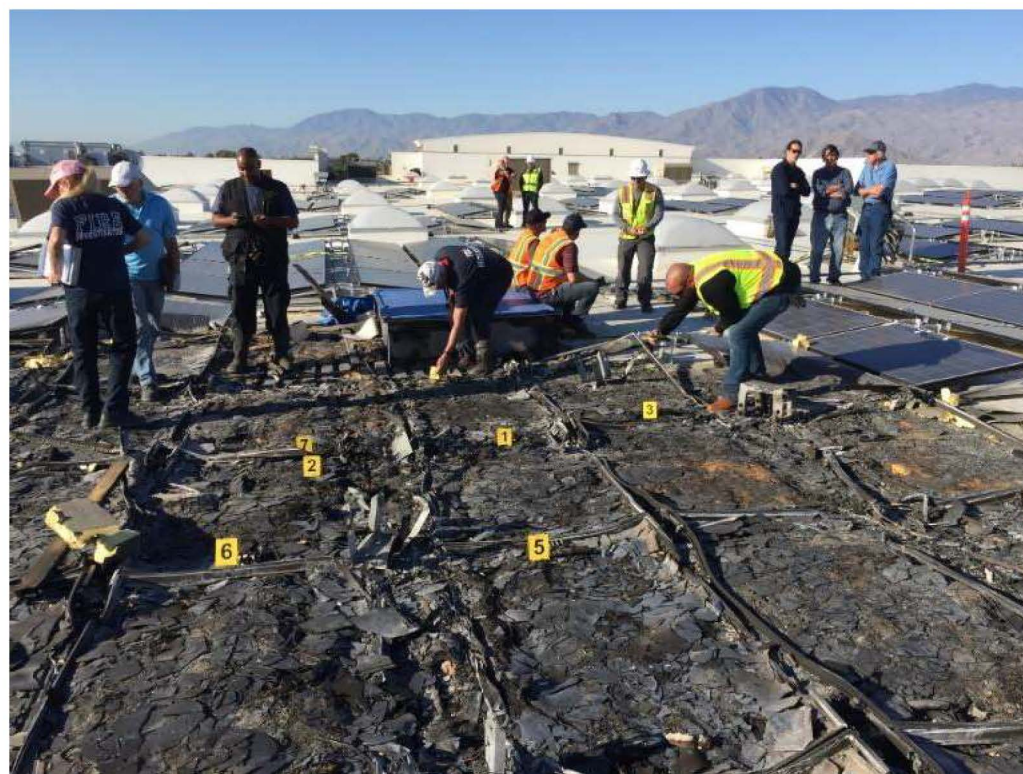
Inspection Team at Site of Indio Fire

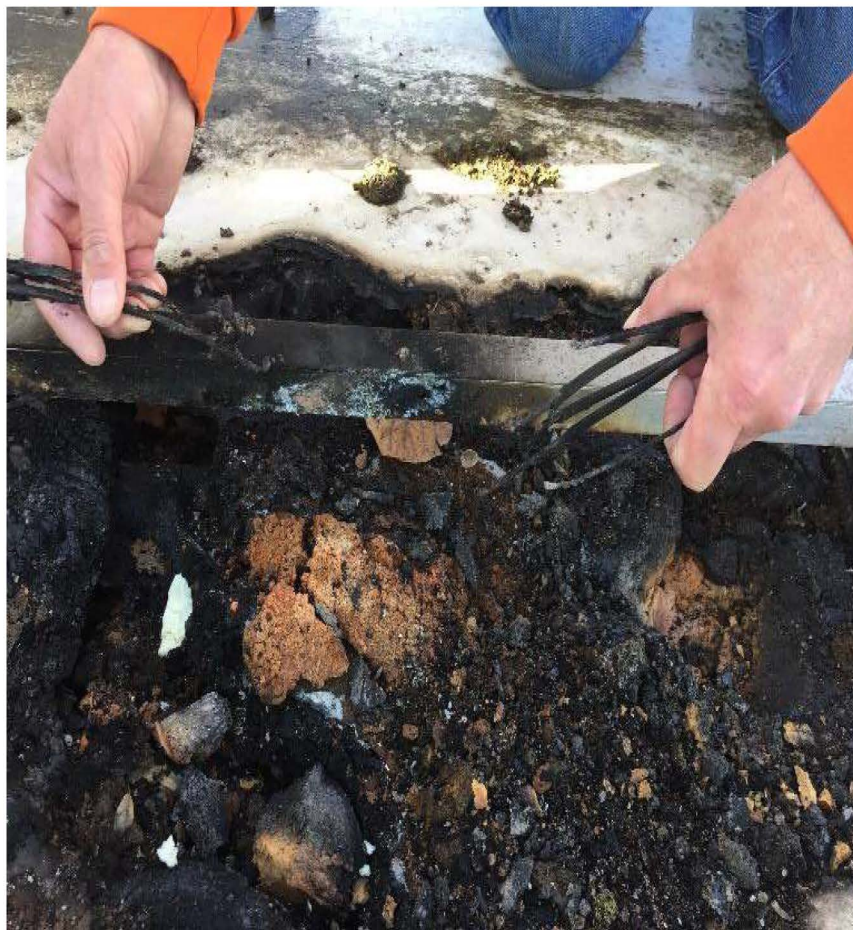
wires were still sparking at the time of discovery, indicating that the fire had occurred recently. Photographs also revealed that arcing had affected numerous wires at the Yuba City site over an extended period of time, degrading the wires' insulation and resulting in the incineration of a substantial section of the store's roof. The extent of the damage to the wires indicated that the fire was sufficiently severe that it could have burned the entire store to the ground. Because of Tesla's failure to provide a final root cause analysis, Walmart has no assurance that the next store to experience a Tesla-caused fire will be so fortunate.

Images of Yuba City Roof, Evidencing Fire and Arcing

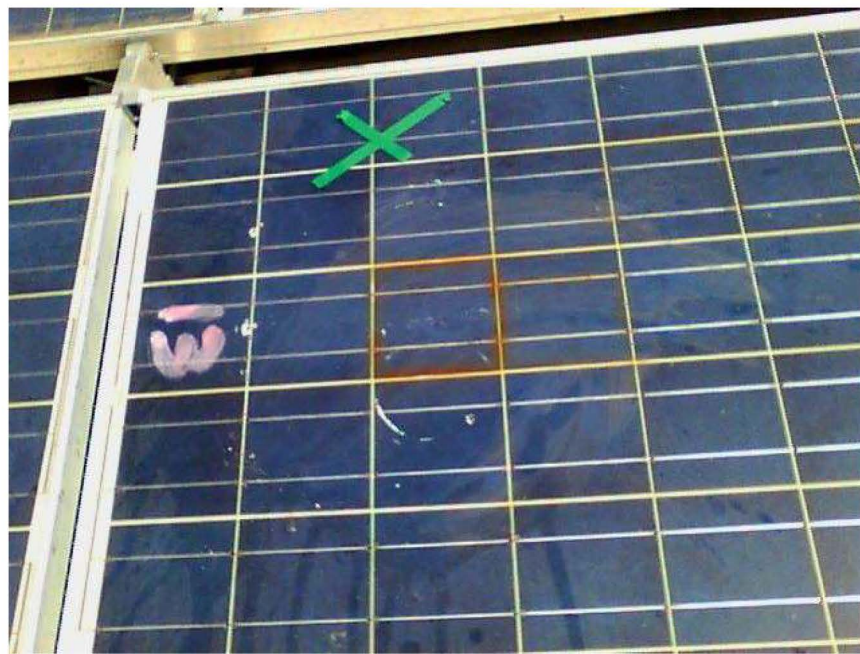
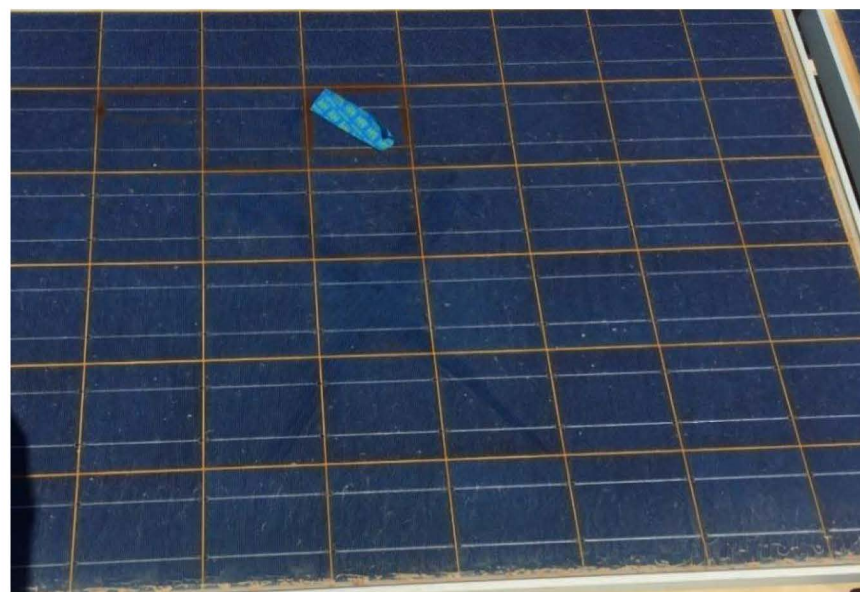
88. Making matters worse, Tesla had flagged or identified hotspots by placing pieces of tape over the affected areas. Because this tape prevented sunlight from reaching the solar panel, it exacerbated the problem by further concentrating heat in certain areas of the solar module—an extremely basic error that a competent inspection team would never have committed.

Images of Tape Used (Improperly) to Flag Hotspots on Walmart Roofs

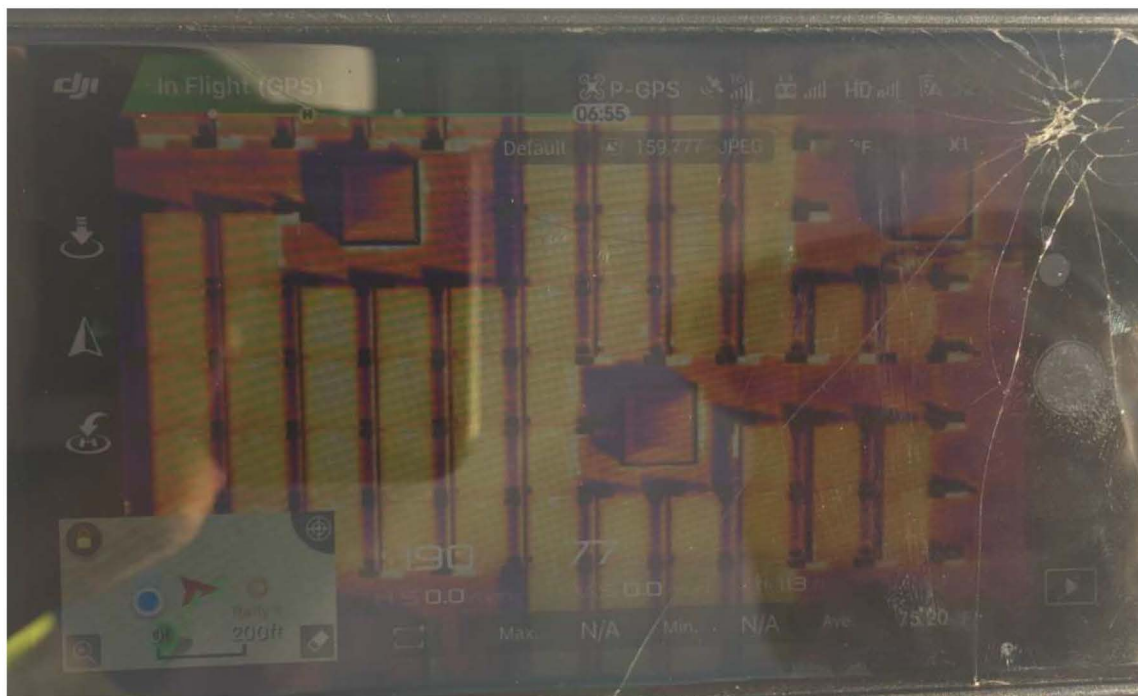
89. Tesla's inspectors also had not implemented proper means of locating and remediating hotspots. They had not adopted uniform standards or directives for identifying hotspots and had not developed criteria to identify when heat differentials between different parts of a module (or different modules) qualified as a hotspot. To locate hotspots, Tesla's inspectors sometimes relied on drones, which generated images of the roofs that lacked sufficient resolution to identify hotspots; as a result, the inspectors missed hotspots that Walmart's consultants found using more reliable methods. On other occasions, Tesla inspectors performed cursory infrared scans from a corner of the roof, but this process did not indicate and would not necessarily have indicated all hotspots across an entire photovoltaic system. Using a thermal gun, a Walmart consultant identified four to six hotspots that Tesla employees had overlooked on just one section of a Walmart roof; one of these hotspots had reached a temperature of over 200 degrees Fahrenheit, as compared to surrounding cells that remained at temperatures of only about 85 degrees Fahrenheit. (The standard temperature differential used to identify a hotspot is a difference of about 60 to 70 degrees Fahrenheit between a solar cell and its surrounding cells. Notably, the solar panels contain plastic components, which begin to degrade at about 160 degrees Fahrenheit.) The hotspots observed during these inspections reflected some of the worst conditions that Walmart's consultants had seen on solar panels over the course of their careers. Some hotspots had resulted in the browning or yellowing of the solar modules and were visible to the naked eye—or should have been, had Tesla's inspectors taken the time to look for them. The conditions were particularly appalling given that hotspots do not develop over the course of one or two days, but rather form over extended periods of time. The prevalence of hotspots on the Tesla systems reflected a long-term pattern of negligence that had gone ignored for years and had not been addressed by proper maintenance procedures.

Image of Drone Scan Showing Inadequate Resolution

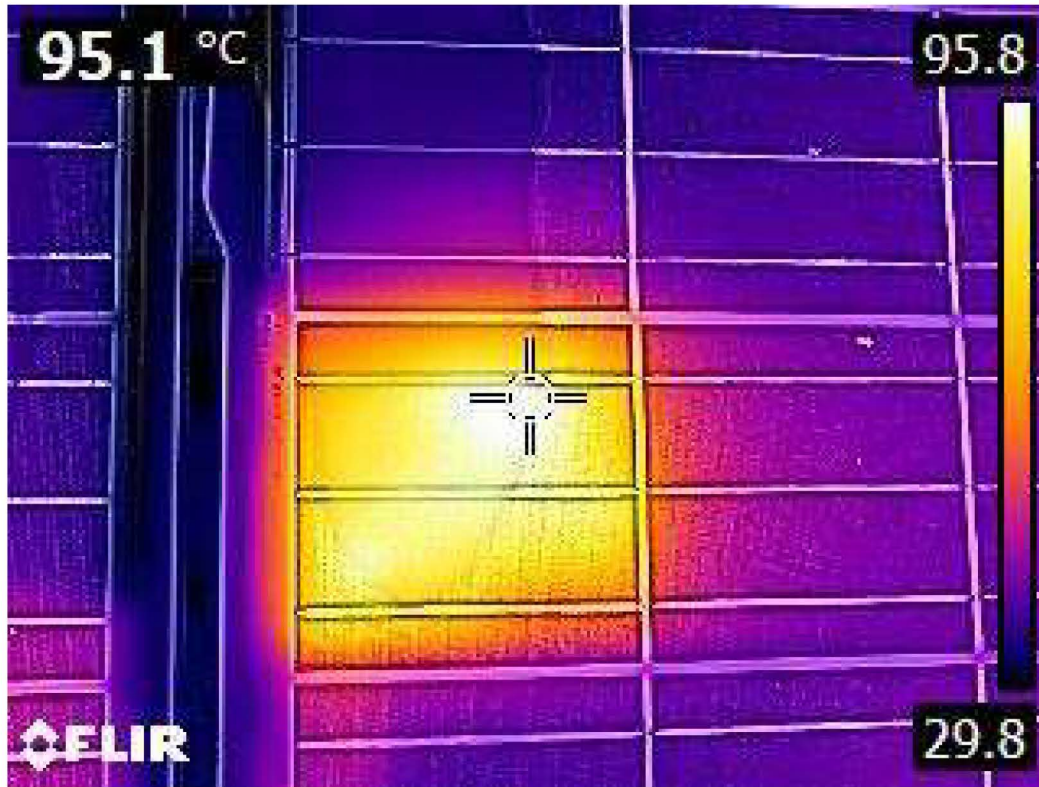
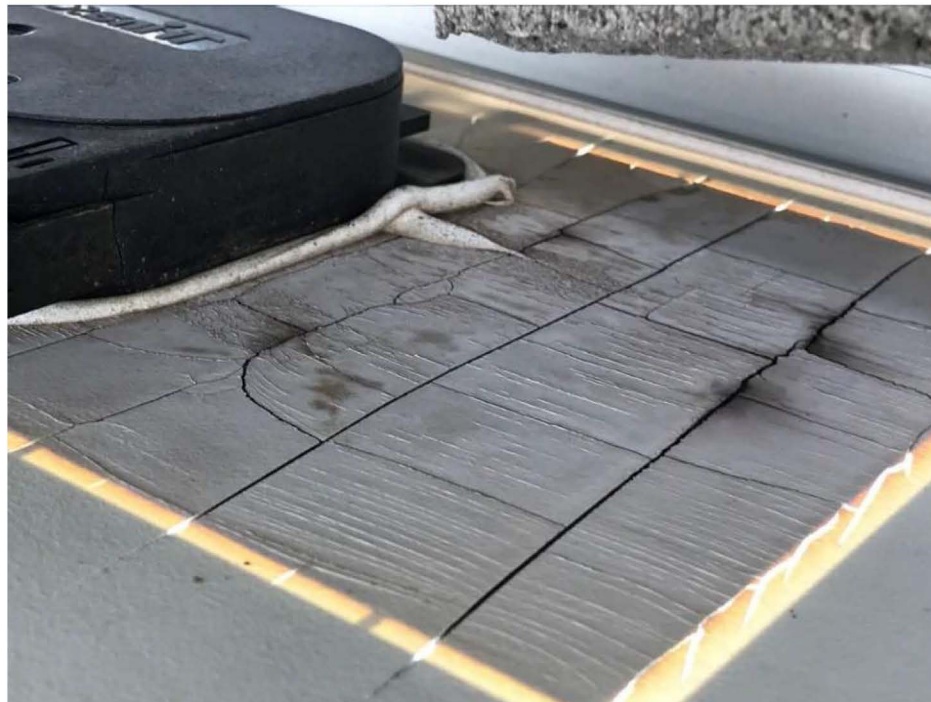
87. Many of the Tesla solar panels inspected by Walmart were suffering from hotspots, resulting in cracking of the back sheets on solar modules and compromising electrical insulation. This condition compounded the danger and substantially heightened the risk of fire: the hotspots reflected an excessive build-up of heat in the solar modules, which in turn wore down the insulation that was designed to keep electrical currents flowing within their proper paths and to separate electric conductors from their surrounding materials. These conditions can readily lead to electrical fires capable of spreading across an entire rooftop.

Images of Hotspots on Solar Modules and Associated Module Cracking

that are precursors to hotspots, including the yellowing of encapsulant (the adhesive material used to connect components of a solar panel module) and the presence of micro-cracks in the solar modules. Both of those conditions reflect degradation of the solar modules in a manner that might affect bypass diodes and thus contribute to significant heat increases in segments of the solar panel systems.

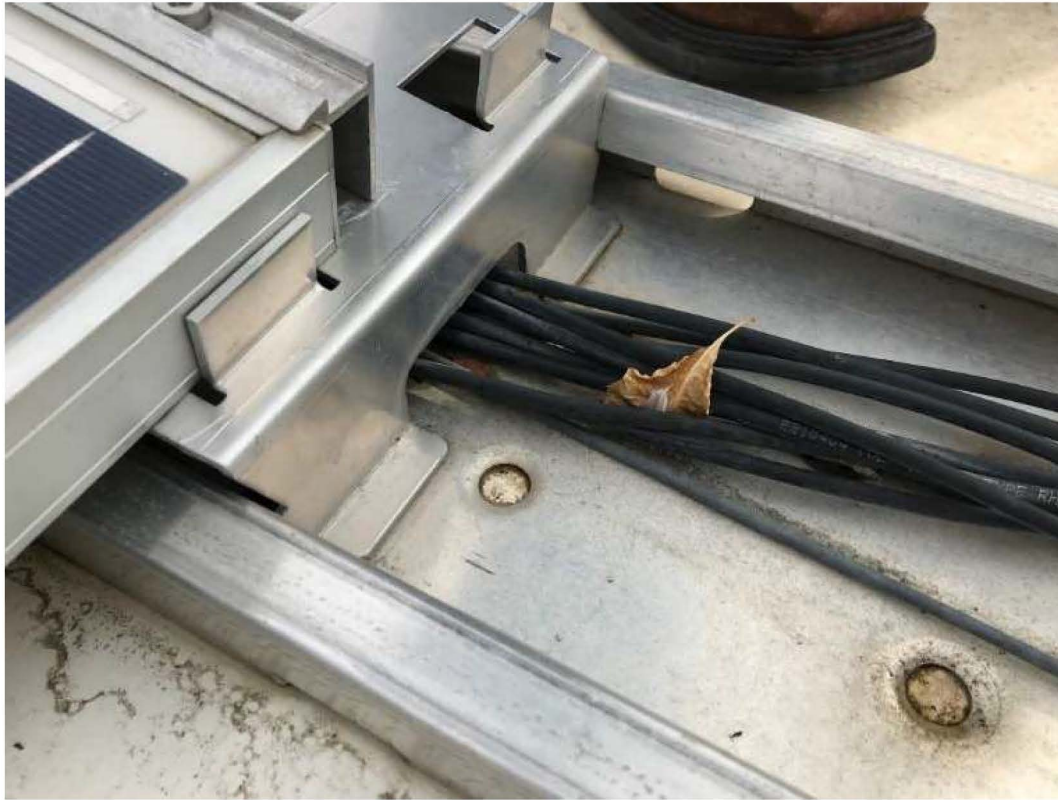
92. Poor wire management practices were also evident at multiple Walmart sites. In some cases, sharp points—from, among other items, rough concrete or metal edges—were cutting into or abrading wires. In other cases, temperature changes resulted in the expansion and contraction of wires over time, moving the wires and resulting in their abrasion or exposure. In still other cases, conduits were overstuffed, containing too many wires to be safely used. And wire insulation failures resulted in the exposure of current-carrying electrical conductors to the elements, creating a substantial safety and fire hazard. By degrading the insulation of the solar panels' wiring, these factors increased the risk that an electric current would deviate from its intended path and cause a fire that would spread to surrounding panels. Many of these issues could have been—but were not—addressed through industry standard maintenance procedures, including resealing or reinsulating exposed wires.

Image of Wires Exposed to Sharp Edges

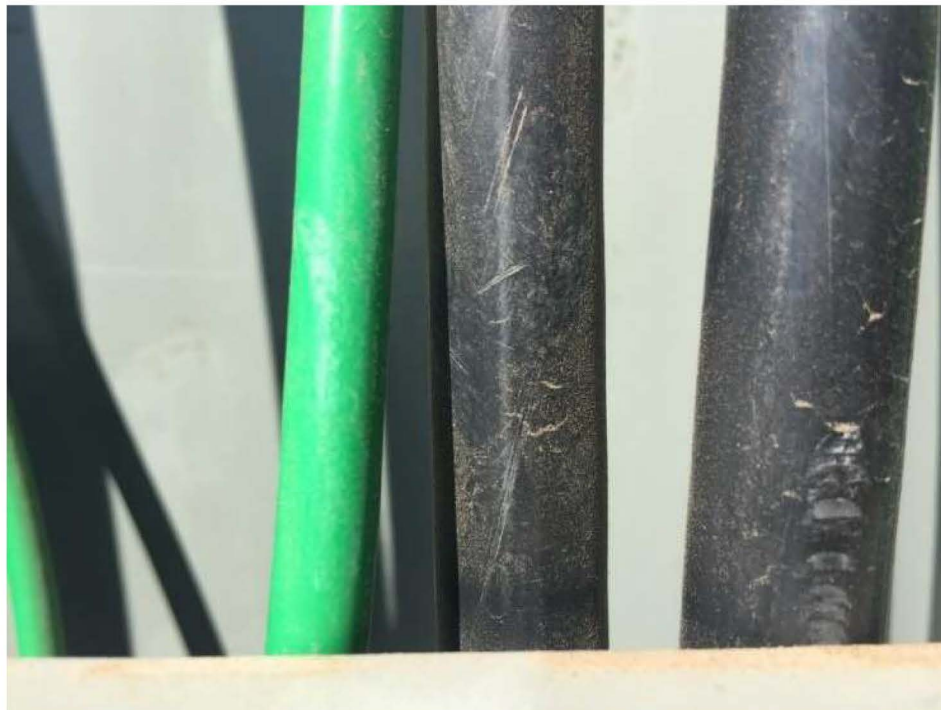
Images of Abraded Wires

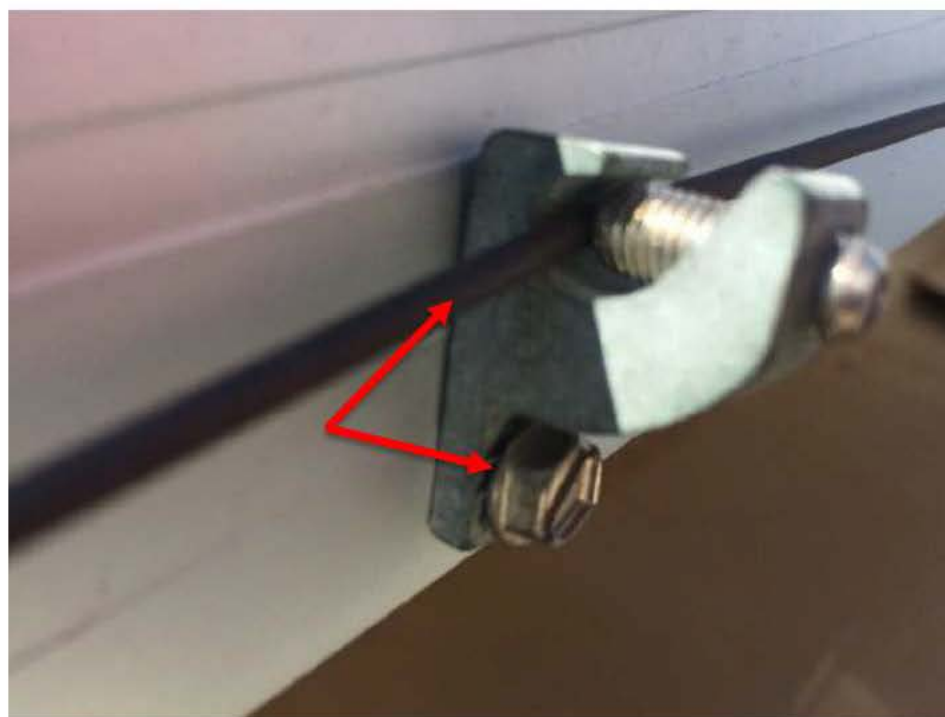
Image of Improper Module Grounding
(Washer Should be Between Lug and Module Frame)

94. With respect to solar photovoltaic systems installed at Walmart stores, proper grounding means that materials conducting electric charges must connect to a grounding electrode outside of the Walmart store. Upon reviewing Tesla's inspections of Walmart stores, however, it became clear that multiple conductors were not properly grounded according to standard principles of electrical systems as outlined in the National Electrical Code. This fact, in conjunction with Tesla's poor wire management practices, demonstrated that Tesla had run afoul of basic industry conventions in the installation, operation, and maintenance of its solar panel systems—and had done so in a way that exposed Walmart stores, customers, and employees to fires.

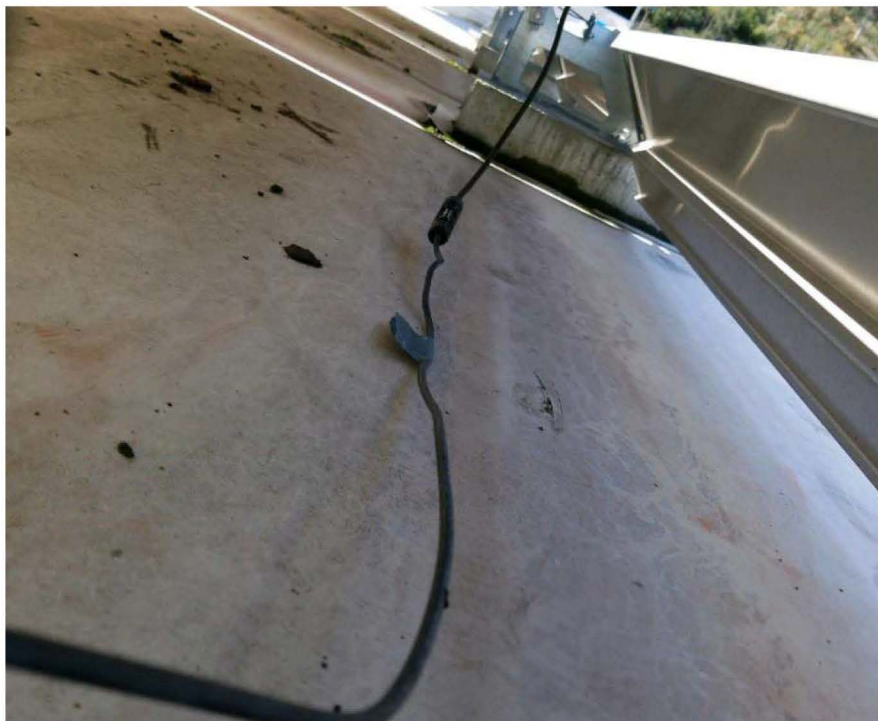
Image of Wire Improperly in Contact with Roof

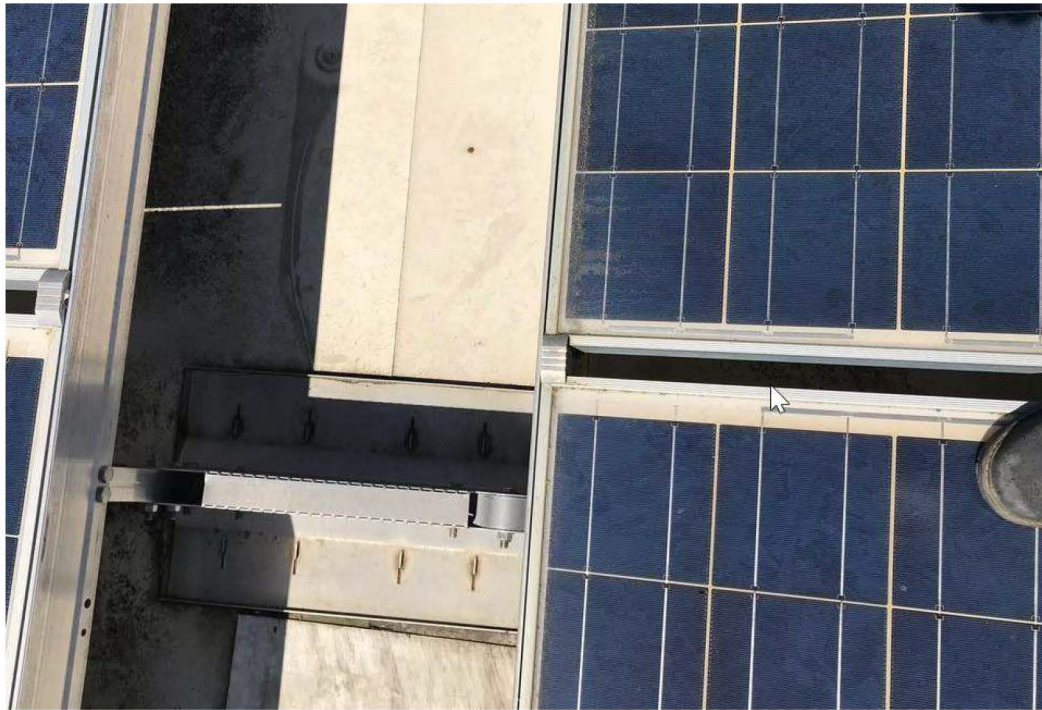
96. Tesla inspection personnel frequently missed or improperly identified obvious and visible risks with the solar panel systems and were often negligent in performing inspections. Most glaringly, Tesla inspection personnel violated elementary safety standards by negligently stepping on modules (potentially contributing to micro-cracks), using the wrong equipment for basic tasks, and—in one instance—leaving a combiner box enclosure open and exposed to the elements after an inspection. Tesla also relied on drone fly-overs and other shortcuts when inspecting sites, rather than sending qualified and properly trained solar inspectors to physically inspect solar panel systems with appropriate equipment—the established industry method for conducting thorough inspections.

Image of Tesla Inspector Stepping on Solar Modules
(Inspector's Foot Visible in Bottom Right of Image)
